Contract #: 04-0120F4Cty: SF/ALA Rte: 80 PM: 13.2/13.9File #: 69.28**WELDING INSPECTION REPORT****Resident Engineer:** Pursell, Gary**Address:** 333 Burma Road**City:** Oakland, CA 94607**Report No:** WIR-009211**Date Inspected:** 22-Sep-2009**Project Name:** SAS Superstructure**OSM Arrival Time:** 1900**Prime Contractor:** American Bridge/Fluor Enterprises, a JV**OSM Departure Time:** 700**Contractor:** Zhenhua Port Machinery Company, Ltd (ZPMC), Changxing Island **Location:** Shanghai, China**CWI Name:** See Below**CWI Present:** Yes No**Inspected CWI report:** Yes No N/A**Rod Oven in Use:** Yes No N/A**Electrode to specification:** Yes No N/A**Weld Procedures Followed:** Yes No N/A**Qualified Welders:** Yes No N/A**Verified Joint Fit-up:** Yes No N/A**Approved Drawings:** Yes No N/A**Approved WPS:** Yes No N/A**Delayed / Cancelled:** Yes No N/A**Bridge No:** 34-0006**Component:** OBG & Tower Fabrication**Summary of Items Observed:**

OBG BAY 2

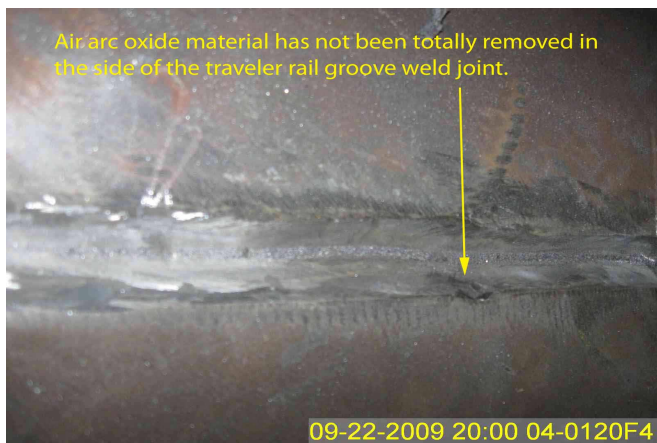
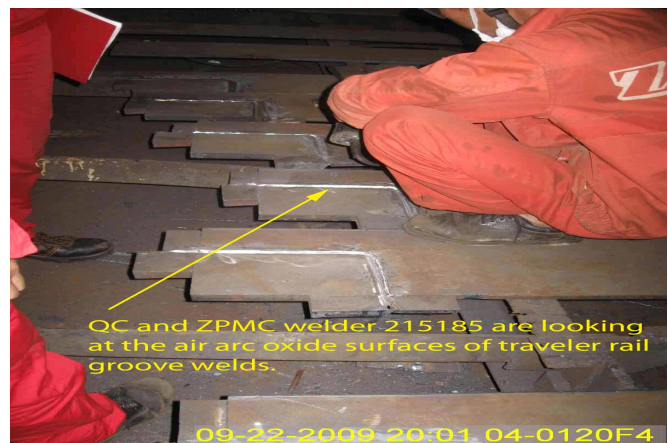
OBG Bay 5

This QA Inspector observed ZPMC welder Mr. Li Yuan Zheng, stencil 217185 is using flux cored welding process WPS-B-T-2231-B-U2-F to make traveler rail flux cored groove weld 10TR-022-3. This QA Inspector measured a welding current of approximately 290 amps and 34.0 volts. ZPMC QC Inspector Mr. Zhong Dong Baio observed that this QA Inspector had measured Mr. Zheng to have 34 volts and Mr. Baio adjusted the welding voltage to 30 volts. This QA Inspector asked ZPMC CWI Mr. Li Yang if Mr. Baio had recently measured the welding parameters and Mr. Yang said the welder had just started welding. This QA Inspector observed ZPMC QC Inspector Mr. Zhong Dong Baio did not have a welding amp probe or a flashlight. This QA Inspector visually inspected several of the traveler rail groove complete joint penetration welds that had been backgouged and ground, and this QA Inspector observed several areas where the weld groove had not been ground to a bright metal condition and that there are localized areas where the carbon air arc gouge oxidized surface is visible. This QA Inspector used a flashlight to show ZPMC QC Inspector Mr. Zhong Dong Baio and ZPMC CWI Mr. Li Yang these oxidized weld groove surfaces and Mr. Baio said he will have the areas ground. This QA Inspector asked Mr. Yang if Mr. Baio can perform adequate visual inspections of these groove welds without a flashlight. Mr. Yang said he will ensure Mr. Baio uses a flashlight to inspect the other groove welds prior to welding. This QA Inspector observed that Mr. Li Yuan Zheng is certified to make this weld. Items observed on this date do not fully comply with applicable contract documents.
